**Flood Control Project Maintenance  
Levee Inspections**

**Fall 2015 Levee Maintenance Deficiency Summary Report**

**Sutter Maintenance Yard Maintenance Area 0012**

Waterway			Bank	Unit Miles
Unit No. 01 Colusa Drain			Left	11.06
	Spring (March - May)	Summer (June - August)	(September - November) Fall	Winter (December - February)
Unit Maintenance Rating (Fall Only)			A	
Date of Inspection	03/11/2015 - 03/11/2015		09/15/2015 - 09/15/2015	
DWR Inspector	Bob Duffey		Bob Duffey	
Accompanied By	Bryan Reniff Sutter Maintenance Yard		Bryan Reniff Sutter Maintenance Yard

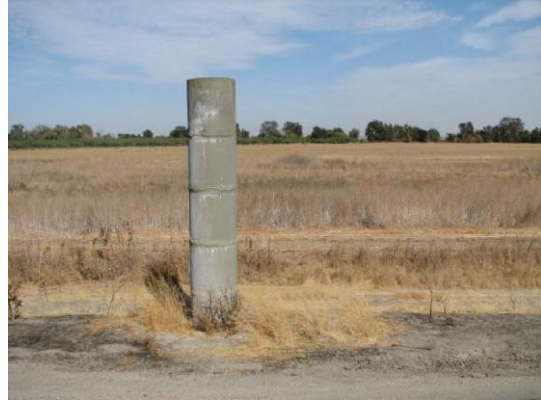
Photo 1 of 1 : UCIP\_FA\_2015\_6765.jpg

LM Start	0.23	Rating **	M	Issue No.	207
LM End	0.23	Issue Type +	En	Location *	N/A
Category	Supplemental			GPS Latitude/Longitude	
				Start	End
Item	DWR UCIP Field Study			39.035889 °	39.035889 °
				-121.996882 °	-121.996882 °
DWR ID					
Action/Comments					
Inspector Comments: FS_ID:44933 DS_ID:17145 EP_NO: 9381 FS_HLM: 0.24 Repair Type: Non-Urgent Crossing Status: Indicator Found UCIP Comments: 5/4/2015 Abandoned crossing.Need to verify proper abandonment of pipe.7/16/2013 Same as last inspection.12/16/2013 Same as last inspection.6/17/2014 Same as last inspection. FIELD_STRUCT_DESC: *Abandoned* 14-inch pipe through levee, 3.0 feet below crown. Open on waterward end. 3-foot x 6-foot concrete well on waterward berm. Siphon breaker in 24-inch pipe riser on landward shoulder. 36-inch concrete standpipe on landward berm. (Permit No. 9381 - Tribble). Originally included in O+M Manual (1959). Asbuilt available 50-4-3081. (The only item identified is the 36-inch standpipe on the LS toe). FS Date: 05/05/2015

36-inch concrete riser on LS toe.

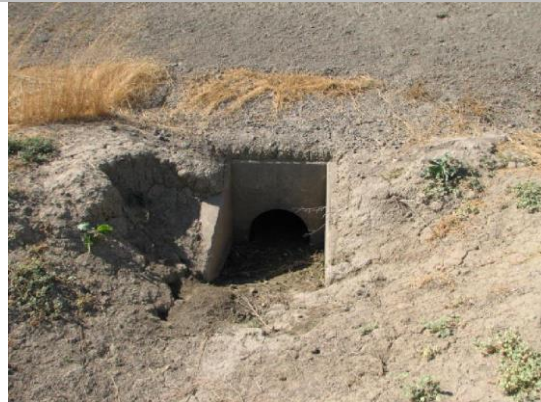
Photo 1 of 3 : UCIP\_FA\_2015\_6766.jpg

LM Start	0.49	Rating **	U	Issue No.	208
LM End	0.49	Issue Type +	En	Location *	N/A
Category	Supplemental			GPS Latitude/Longitude	
				Start	End
Item	DWR UCIP Field Study			39.039413 °	39.039413 °
				-121.997766 °	-121.997766 °
DWR ID					
Action/Comments					
Inspector Comments: FS_ID:44939 DS_ID:17146 EP_NO: 9382 FS_HLM: 0.502 Repair Type: Urgent Crossing Status: Found UCIP Comments: 5/4/2015 WS flap gate is blocked by sediment and unable to open. LS inlet is about 50% plugged with soil. Needs to be cleaned.Pipe is partially filled with soil.7/16/2013 Sediment is built up against WS flapgate preventing it from opening.12/16/2013 Sediment against flapgate has been cleared and it can now function properly.6/17/2014 Same as last inspection. FIELD_STRUCT_DESC: 24-inch CM drain pipe through levee, 13.0 feet below the crown. Flap gate, concrete headwall and grouted cobble spillway on waterward side. Concrete headwall on landward side. (Permit No. 9382 Baber). Originally included in O+M manual (1959). Asbuilt available 50-4-3081. FS Date: 05/05/2015

Inlet and concrete headwall on LS toe.

Inspector Comments: FS\_ID:44939  
 DS\_ID:17146  
 EP\_NO: 9382  
 FS\_HLM: 0.502  
 Repair Type: Urgent  
 Crossing Status: Found  
 UCIP Comments: 5/4/2015 WS flap gate is blocked by sediment and unable to open. LS inlet is about 50% plugged with soil. Needs to be cleaned. Pipe is partially filled with soil. 7/16/2013 Sediment is built up against WS flapgate preventing it from opening. 12/16/2013 Sediment against flapgate has been cleared and it can now function properly. 6/17/2014 Same as last inspection.  
 FIELD\_STRUCT\_DESC: 24-inch CM drain pipe through levee, 13.0 feet below the crown. Flap gate, concrete headwall and grouted cobble spillway on waterward side. Concrete headwall on landward side. (Permit No. 9382 Baber). Originally included in O+M manual (1959). Asbuilt available 50-4-3081.  
 FS Date: 05/05/2015

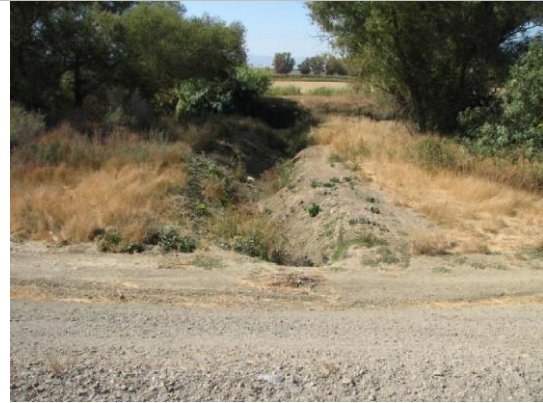
Photo 2 of 3 : UCIP\_FA\_2015\_6767.jpg

Outlet at WS toe.

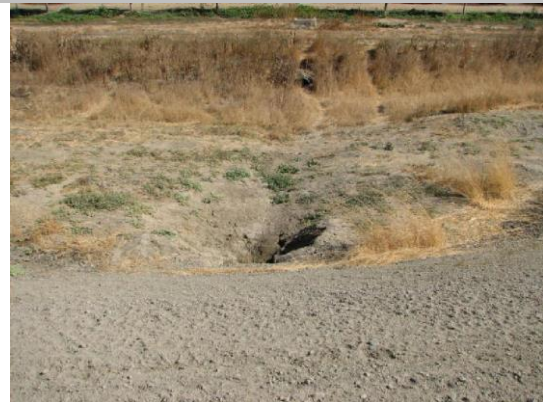
Photo 3 of 3 : UCIP\_FA\_2015\_6768.jpg

Intake at LS toe.

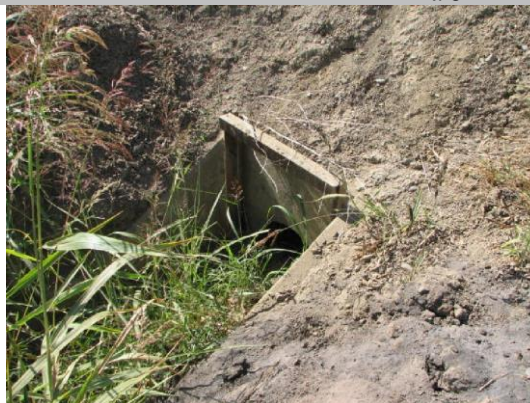
Photo 1 of 3 : UCIP\_FA\_2015\_3744.jpg

LM Start	1.69	Rating **	U	Issue No.	209
LM End	1.69	Issue Type +	En	Location *	N/A
Category	Supplemental			GPS Latitude/Longitude	
				Start	End
Item	DWR UCIP Field Study			39.055711 °	39.055711 °
				-122.003252 °	-122.003252 °
DWR ID					
Action/Comments					
Inspector Comments: FS_ID:44945					
DS_ID:17149					
EP_NO: 9382					
FS_HLM: 1.727					
Repair Type: Urgent					
Crossing Status: Found

Concrete U shaped headwall at LS inlet.

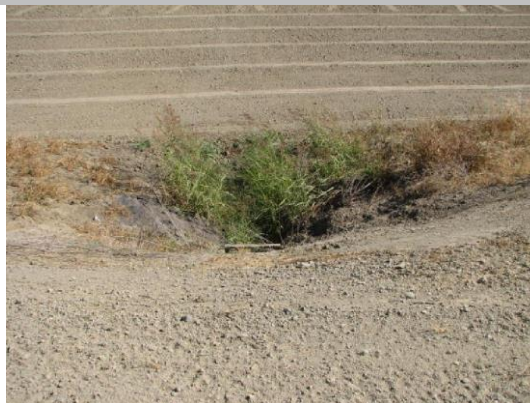
Photo 2 of 3 : UCIP\_FA\_2015\_3745.jpg

Inlet on LS toe.

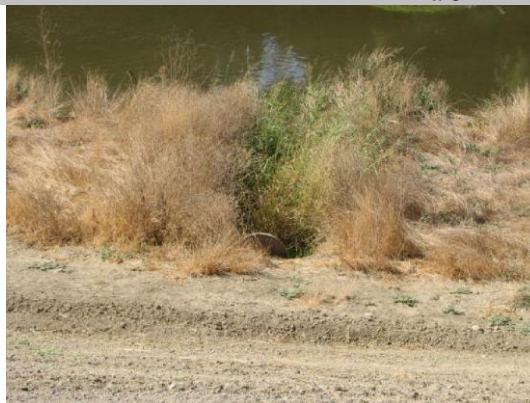
Photo 3 of 3 : UCIP\_FA\_2015\_3746.jpg

LM Start	1.69	Rating **	U	Issue No.	209 (cont)
LM End	1.69	Issue Type +	En	Location *	N/A
Category	Supplemental			GPS Latitude/Longitude	
				Start	End
Item	DWR UCIP Field Study			39.055711 °	39.055711 °
				-122.003252 °	-122.003252 °
DWR ID					
Action/Comments					
Inspector Comments: FS_ID:44945					
DS_ID:17149					
EP_NO: 9382					
FS_HLM: 1.727					
Repair Type: Urgent					
Crossing Status: Found

Outlet on WS toe.

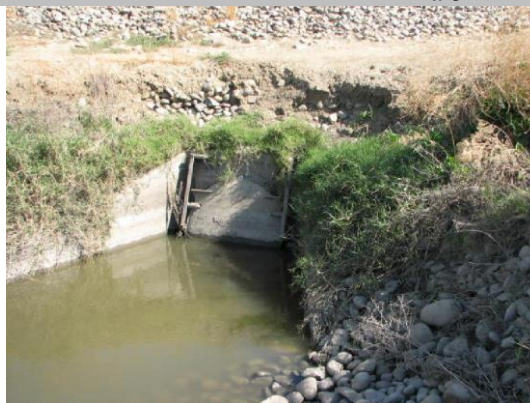
Photo 1 of 2 : UCIP\_FA\_2015\_3747.jpg

LM Start	1.77	Rating **	U	Issue No.	210
LM End	1.77	Issue Type +	En	Location *	N/A
Category	Supplemental			GPS Latitude/Longitude	
				Start	End
Item	DWR UCIP Field Study			39.056847 °	39.056847 °
				-122.003288 °	-122.003288 °
DWR ID					
Action/Comments					
Inspector Comments: FS_ID:44954 DS_ID:17150 EP_NO: 9387 FS_HLM: 1.81 Repair Type: Urgent Crossing Status: Found UCIP Comments: 5/4/2015 WS flapgate mostly underwater but could tell it was blocked open by something. LS inlet is located about 1/4 mile north along the side of the roadway.No inlet could be located on LS. Flap gate partially blocked and will not close completely.7/16/2013 Same as last inspection. Was told inlet is about 1/4 mile down road way next to house. Will try to get coordinates for inlet.12/16/2013 Pipe was flowing water and flap gate was bing pushed open. Cannot verify if it will close all the way.6/17/2014 Same as last inspection. FIELD_STRUCT_DESC: 48-inch drain pipe through the levee 20.0 feet below crown. Slide gate in 60-inch pipe riser on waterward slope. Flap gate and concrete headwall on waterward side. (Permit No. 9387 - Christenson). Originally included in O+M manual (1959). FS Date: 05/05/2015

Flap gate and concrete headwall at WS toe.

Inspector Comments: FS\_ID:44954  
DS\_ID:17150  
EP\_NO: 9387  
FS\_HLM: 1.81  
Repair Type: Urgent  
Crossing Status: Found  
UCIP Comments: 5/4/2015 WS flapgate mostly underwater but could tell it was blocked open by something. LS inlet is located about 1/4 mile north along the side of the roadway.No inlet could be located on LS. Flap gate partially blocked and will not close completely.7/16/2013 Same as last inspection. Was told inlet is about 1/4 mile down road way next to house. Will try to get coordinates for inlet.12/16/2013 Pipe was flowing water and flap gate was bing pushed open. Cannot verify if it will close all the way.6/17/2014 Same as last inspection.  
FIELD\_STRUCT\_DESC: 48-inch drain pipe through the levee 20.0 feet below crown. Slide gate in 60-inch pipe riser on waterward slope. Flap gate and concrete headwall on waterward side. (Permit No. 9387 - Christenson). Originally included in O+M manual (1959).

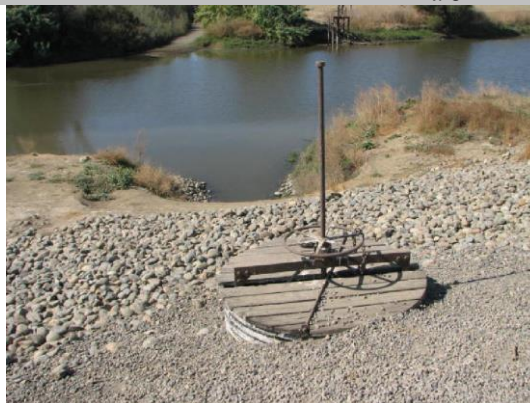
Photo 2 of 2 : UCIP\_FA\_2015\_3748.jpg

60-inch standpipe with slide gate on WS slope with outlet in background.

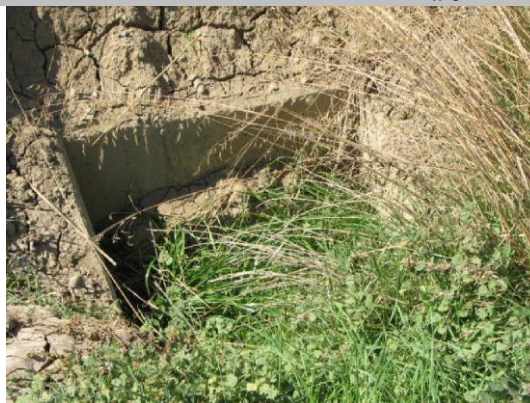
Photo 1 of 3 : UCIP\_FA\_2015\_3749.jpg

Inspector Comments: FS\_ID:44955  
DS\_ID:17151  
EP\_NO: 9391  
FS\_HLM: 2.02  
Repair Type: Urgent  
Crossing Status: Found  
UCIP Comments: 5/4/2015 LS and WS ends are blocked with soil. Pipe is inoperable as it is.Inlet is partially filled with soil.7/16/2013 LS inlet is completely filled with soil. Needs to be cleaned out.12/16/2013 Same as last inspection.6/17/2014 Same as last inspection.  
FIELD\_STRUCT\_DESC: 24-inch CM drain pipe through levee, 13.0 feet below crown. Flap gate, concrete headwall and grouted cobble spillway on the waterward side. Concrete headwall on landward side. (Permit No. 9391 Christenson). Originally included in O+M manual (1959).  
FS Date: 05/05/2015

Concrete U shaped headwall at LS toe.

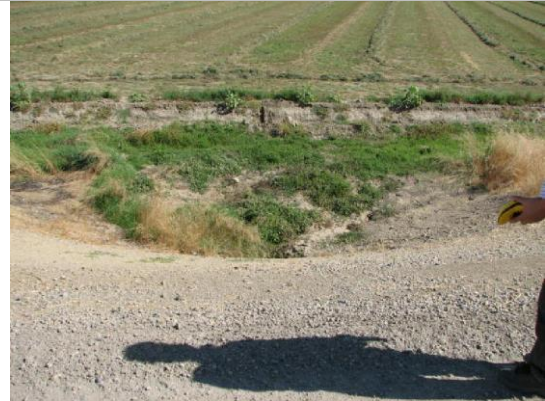
Photo 2 of 3 : UCIP\_FA\_2015\_3750.jpg

LM Start	1.98	Rating **	U	Issue No.	211 (cont)
LM End	1.98	Issue Type +	En	Location *	N/A
Category	Supplemental			GPS Latitude/Longitude	
				Start	End
Item	DWR UCIP Field Study			39.059773 °	39.059773 °
				-122.004391 °	-122.004391 °
DWR ID					
Action/Comments					
Inspector Comments: FS_ID:44955 DS_ID:17151 EP_NO: 9391 FS_HLM: 2.02 Repair Type: Urgent Crossing Status: Found UCIP Comments: 5/4/2015 LS and WS ends are blocked with soil. Pipe is inoperable as it is. Inlet is partially filled with soil. 7/16/2013 LS inlet is completely filled with soil. Needs to be cleaned out. 12/16/2013 Same as last inspection. 6/17/2014 Same as last inspection. FIELD_STRUCT_DESC: 24-inch CM drain pipe through levee, 13.0 feet below crown. Flap gate, concrete headwall and grouted cobble spillway on the waterward side. Concrete headwall on landward side. (Permit No. 9391 Christenson). Originally included in O+M manual (1959). FS Date: 05/05/2015

LS view of inlet.

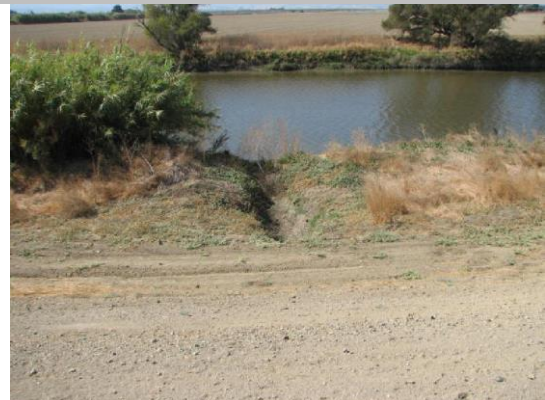
Photo 3 of 3 : UCIP\_FA\_2015\_3751.jpg

WS view of outlet.

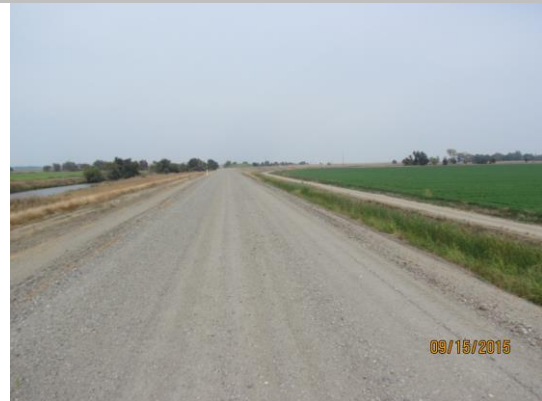
Photo 1 of 1 : FA\_2015\_MA0012\_299\_25\_20151013\_00006.jpg

LM Start	3.43	Rating **	A	Issue No.	25
LM End	3.43	Issue Type +	Ma	Location *	LS
Category	Earthen Levee			GPS Latitude/Longitude	
				Start	End
Item	Vegetation			39.078165 °	39.078165 °
				-122.016040 °	-122.016040 °
DWR ID	DWR_MA0012_01_f_2015_25				
Action/Comments					
Control annual grass and weeds on the levee slopes and easements. Inspector Comments: Sutter Yard burned and dragged both slopes.

View of the levee with no vegetation on both slopes.

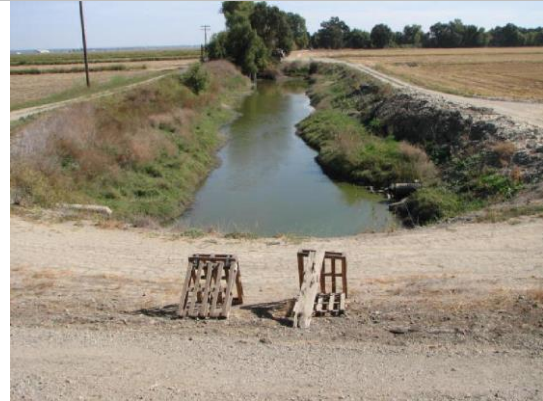
Photo 1 of 2 : UCIP\_FA\_2015\_3752.jpg

Action/Comments					
Inspector Comments: FS_ID:44963					
DS_ID:17154					
EP_NO: 9388					
FS_HLM: 3.777					
Repair Type: Urgent					
Crossing Status: Found					
UCIP Comments: 5/4/2015 Slide gate stem is still bent. Gate looks to be unable to close all the way. Slide gate inoperable, but appears to be in closed position. Flap gate held in open position. Good candidate for video inspection when, if ever, dry. 7/16/2013 Water flowing through pipe so screw gate definitely not closed. Was told NOV's have been sent for owner to replace stem. Flap gate gets closed for flood season. 12/16/2013 Slide gate stem is still bent. WS flapgate was closed. 6/17/2014 Same as last inspection.					
FIELD_STRUCT_DESC: 48-inch CM pipe through the levee, 28.0 feet below the crown. Slide gate in 66-inch pipe riser on the waterward slope. Concrete headwall on the waterward side. Grouted cobble spillway from drain ditch to large canal on the landward side. (Permit No. 9388 Wallace) Originally included in the O+M manual (1959).

Drainage ditch on LS toe.

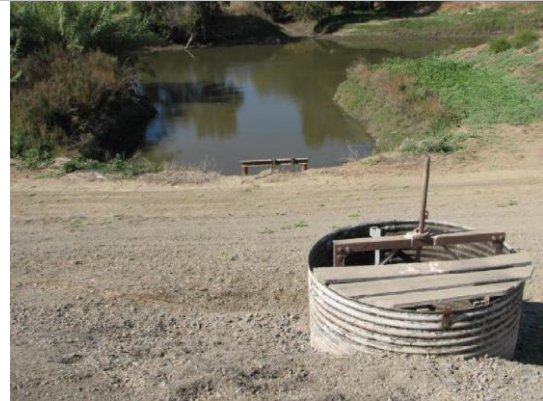
Photo 2 of 2 : UCIP\_FA\_2015\_3753.jpg

Action/Comments					
Inspector Comments: FS_ID:44963 DS_ID:17154 EP_NO: 9388 FS_HLM: 3.777 Repair Type: Urgent Crossing Status: Found UCIP Comments: 5/4/2015 Slide gate stem is still bent. Gate looks to be unable to close all the way. Slide gate inoperable, but appears to be in closed position. Flap gate held in open position. Good candidate for video inspection when, if ever, dry. 7/16/2013 Water flowing through pipe so screw gate definitely not closed. Was told NOV's have been sent for owner to replace stem. Flap gate gets closed for flood season. 12/16/2013 Slide gate stem is still bent. WS flapgate was closed. 6/17/2014 Same as last inspection. FIELD_STRUCT_DESC: 48-inch CM pipe through the levee, 28.0 feet below the crown. Slide gate in 66-inch pipe riser on the waterward slope. Concrete headwall on the waterward side. Grouted cobble spillway from drain ditch to large canal on the landward side. (Permit No. 9388 Wallace) Originally included in the O+M manual (1959). FS Date: 05/05/2015

Slide gate in corrugated metal riser on WS slope.

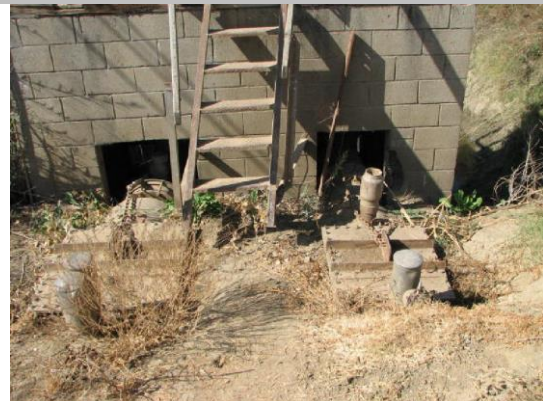
Photo 1 of 3 : UCIP\_FA\_2015\_5187.jpg

Action/Comments					
Inspector Comments: FS_ID:44968 DS_ID:20717 EP_NO: N/A FS_HLM: 4.326 Repair Type: Non-Urgent Crossing Status: Found UCIP Comments: 5/4/2015 Corssing appears to be in good condition. No noticeable issues to report. No permit identified for this crossing. 7/16/2013 Same as last inspection. 12/16/2013 Pump has been removed for winter. 6/17/2014 Same as last inspection. Pump reinstalled on pier. FIELD_STRUCT_DESC: 24-inch steel pipe though levee, 4.5 feet below crown. Pump in pump house on waterward bank. Siphon breaker valve installed on LS shoulder. FS Date: 05/05/2015

Pipe on seft side of photo.

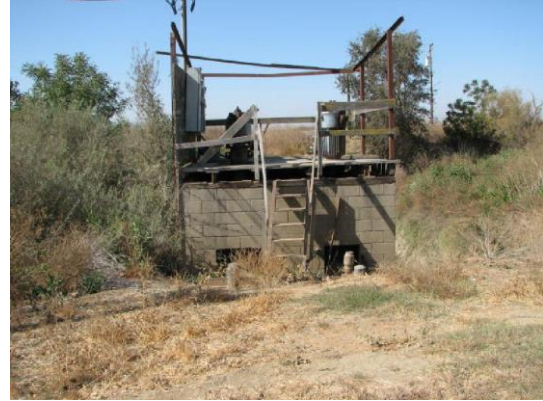
Photo 2 of 3 : UCIP\_FA\_2015\_5188.jpg

Inspector Comments: FS\_ID:44968  
DS\_ID:20717  
EP\_NO: N/A  
FS\_HLM: 4.326  
Repair Type: Non-Urgent  
Crossing Status: Found  
UCIP Comments: 5/4/2015 Corssing appears to be in good condition.  
No noticeable issues to report.No permit identified for this crossing.7/16/2013 Same as last inspection.12/16/2013 Pump has been removed for winter.6/17/2014 Same as last inspection. Pump reinstalled on pier.  
FIELD\_STRUCT\_DESC: 24-inch steel pipe though levee, 4.5 feet below crown. Pump in pump house on waterward bank. Siphon breaker valve installed on LS shoulder.  
FS Date: 05/05/2015

Pumping plant on WS toe.

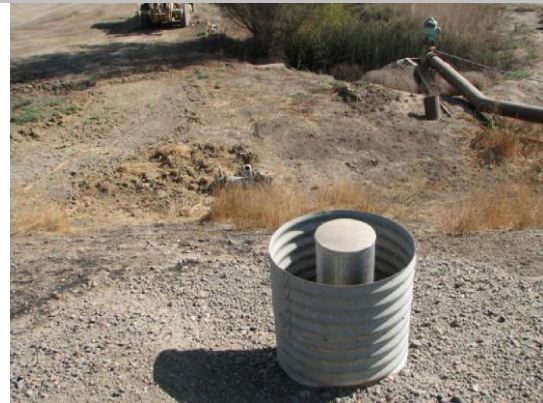
Photo 3 of 3 : UCIP\_FA\_2015\_6236.jpg

Possible siphon breaker for pipe on LS shoulder.

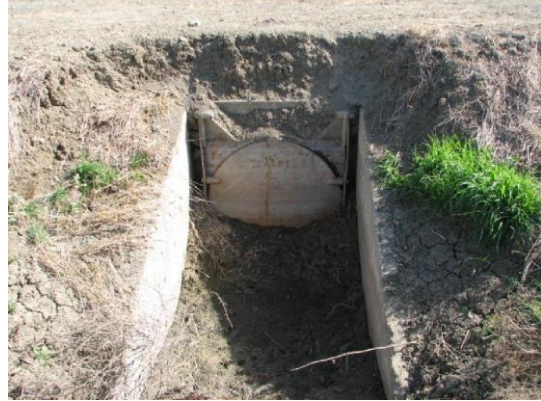
Photo 1 of 3 : UCIP\_FA\_2015\_6237.jpg

Inspector Comments: FS\_ID:44970  
 DS\_ID:17191  
 EP\_NO: N/A  
 FS\_HLM: 5.121  
 Repair Type: Urgent  
 Crossing Status: Found  
 UCIP Comments: 5/4/2015 WS flapgate is blocked by sediment and unable to open. LS inlet is hidden by sediment and heavy vegetation and unable to be located. Needs to be cleared. Pipe is clogged at both the inlet and outlet. Good candidate for video inspection. 7/16/2013 Same as last inspection. 12/16/2013 Same as last inspection. 6/17/2014 Same as last inspection.  
 FIELD\_STRUCT\_DESC: 48-inch CM pipe approximately 15 feet below the crown. Concrete headwalls on both ends with an automatic drainage gate on the WS.  
 FS Date: 05/05/2015

Concrete U shaped headwall and flap gate on WS toe.

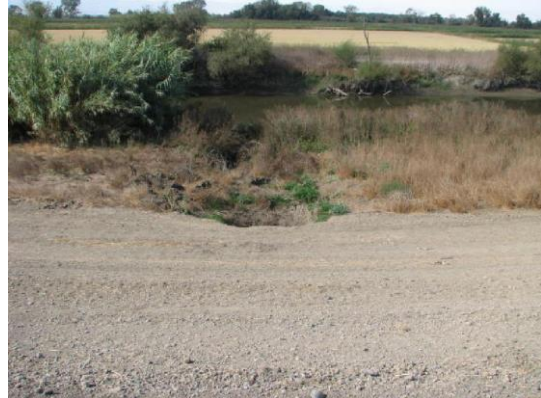
Photo 2 of 3 : UCIP\_FA\_2015\_6238.jpg

Outlet on WS toe.

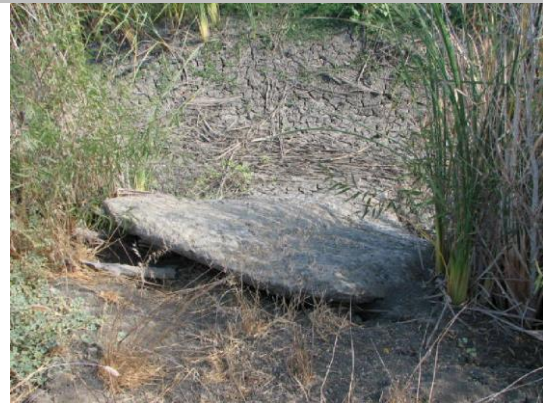
Photo 3 of 3 : UCIP\_FA\_2015\_6239.jpg

LM Start	5.01	Rating **	U	Issue No.	214 (cont)
LM End	5.01	Issue Type +	En	Location *	LS
Category	Supplemental			GPS Latitude/Longitude	
				Start	End
Item	DWR UCIP Field Study			39.100898 °	39.100898 °
				-122.016078 °	-122.016078 °
DWR ID					
Action/Comments					
Inspector Comments: FS_ID:44970					
DS_ID:17191					
EP_NO: N/A					
FS_HLM: 5.121					
Repair Type: Urgent					
Crossing Status: Found

Apparent inlet clogged with concrete or grout on LS toe in drainage swale.

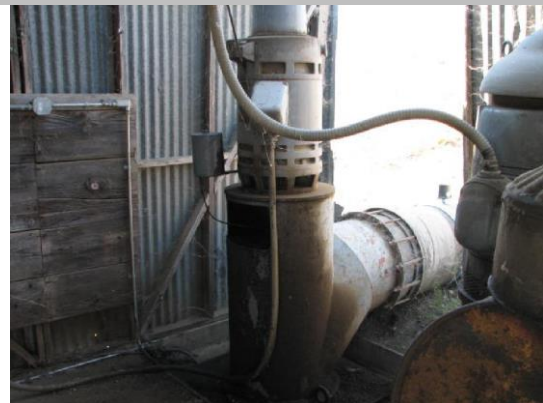
Photo 1 of 3 : UCIP\_FA\_2015\_6240.jpg

LM Start	5.98	Rating **	M	Issue No.	215
LM End	5.98	Issue Type +	En	Location *	LS
Category	Supplemental			GPS Latitude/Longitude	
				Start	End
Item	DWR UCIP Field Study			39.114949 °	39.114949 °
				-122.017946 °	-122.017946 °
DWR ID					
Action/Comments					
Inspector Comments: FS_ID:44973					
DS_ID:20715					
EP_NO: 13699					
FS_HLM: 6.116					
Repair Type: Non-Urgent					
Crossing Status: Found

Pump with oil leakage shown on side of pipe.

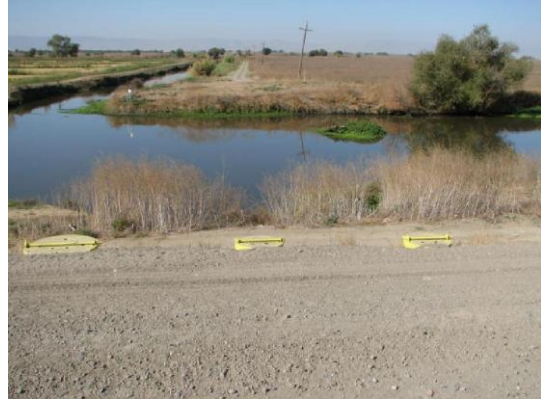
Photo 2 of 3 : UCIP\_FA\_2015\_6241.jpg

LM Start	5.98	Rating **	M	Issue No.	215 (cont)
LM End	5.98	Issue Type +	En	Location *	LS
Category	Supplemental			GPS Latitude/Longitude	
				Start	End
Item	DWR UCIP Field Study			39.114949 °	39.114949 °
				-122.017946 °	-122.017946 °
DWR ID					
Action/Comments					
Inspector Comments: FS_ID:44973 DS_ID:20715 EP_NO: 13699 FS_HLM: 6.116 Repair Type: Non-Urgent Crossing Status: Found UCIP Comments: 5/4/2015 Corssing appears to be in good condition. No noticeable issues to report.Oil leakage around pump.7/16/2013 Same as last inspection.12/16/2013 Same as last inspection.6/17/2014 Same as last inspection. FIELD_STRUCT_DESC: 1 of 2: 20-inch soilproofed steel Stormdrain pipe through levee, 4.4 feet below crown. Cobble revetted sump on waterward side. Siphon breaker in 24-inch metal pipe risers on waterward shoulder. Pump house at toe of landward slope. (Permit No. 13699, 1984). Replaced 18-inch pipe at same location. FS Date: 05/05/2015

Siphon Breaker on WS shoulder.

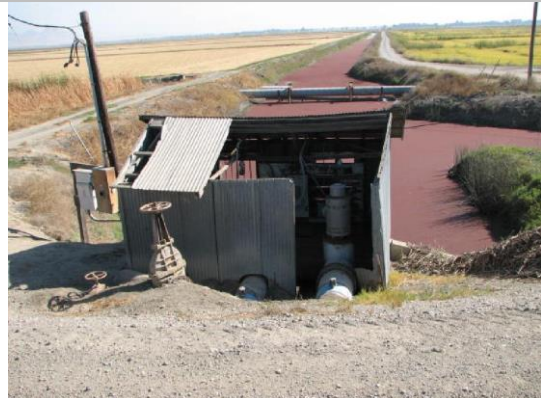
Photo 3 of 3 : UCIP\_FA\_2015\_6288.jpg

Pumping plant on LS slope

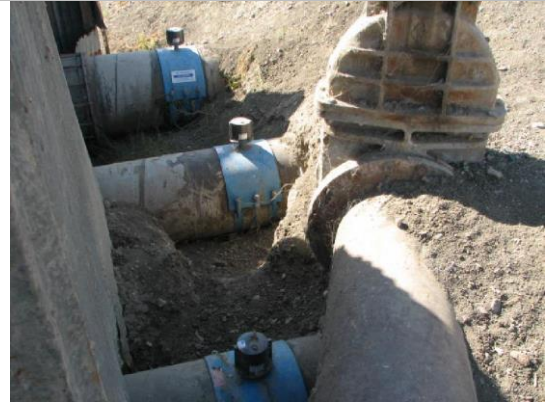
Photo 1 of 3 : UCIP\_FA\_2015\_6289.jpg

LM Start	5.98	Rating **	M	Issue No.	216
LM End	5.98	Issue Type +	En	Location *	LS
Category	Supplemental			GPS Latitude/Longitude	
				Start	End
Item	DWR UCIP Field Study			39.114963 °	39.114963 °
				-122.017947 °	-122.017947 °
DWR ID					
Action/Comments					
Inspector Comments: FS_ID:44974					
DS_ID:20716					
EP_NO: 13699					
FS_HLM: 6.117					
Repair Type: Non-Urgent					
Crossing Status: Found

Pipes on LS slope.

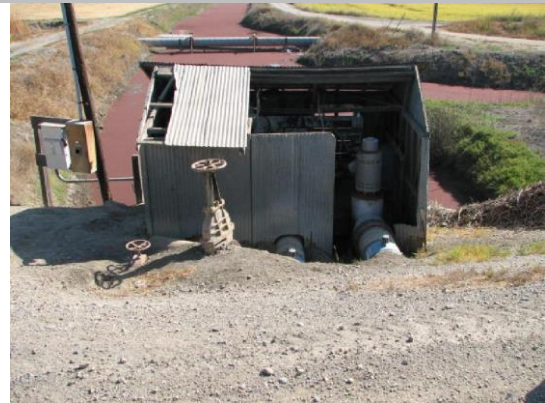
Photo 2 of 3 : UCIP\_FA\_2015\_6290.jpg

Pumphouse on LS slope.

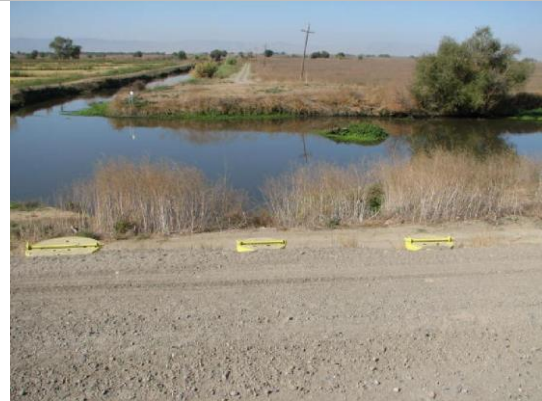
Photo 3 of 3 : UCIP\_FA\_2015\_6291.jpg

LM Start	5.98	Rating **	M	Issue No.	216 (cont)
LM End	5.98	Issue Type +	En	Location *	LS
Category	Supplemental			GPS Latitude/Longitude	
				Start	End
Item	DWR UCIP Field Study			39.114963 °	39.114963 °
				-122.017947 °	-122.017947 °
DWR ID					
Action/Comments					
Inspector Comments: FS_ID:44974					
DS_ID:20716					
EP_NO: 13699					
FS_HLM: 6.117					
Repair Type: Non-Urgent					
Crossing Status: Found

Siphon Breaker on WS shoulder.

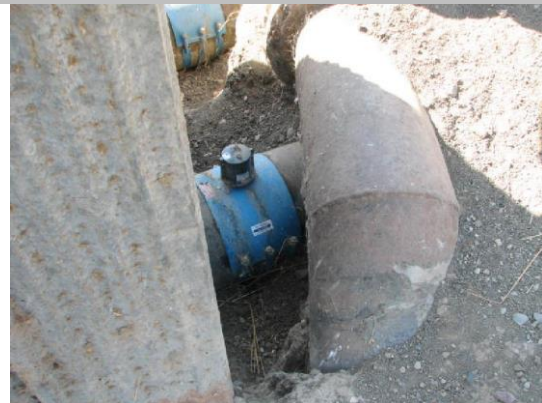
Photo 1 of 3 : UCIP\_FA\_2015\_6445.jpg

LM Start	5.98	Rating **	M	Issue No.	217
LM End	5.98	Issue Type +	En	Location *	LS
Category	Supplemental			GPS Latitude/Longitude	
				Start	End
Item	DWR UCIP Field Study			39.114977 °	39.114977 °
				-122.017947 °	-122.017947 °
DWR ID					
Action/Comments					
Inspector Comments: FS_ID:44977 DS_ID:17199 EP_NO: 9390 FS_HLM: 6.119 Repair Type: Non-Urgent Crossing Status: Found UCIP Comments: 5/4/2015 Corssing appears to be in good condition. No noticeable issues to report.Minor oil leak on pump.7/16/2013 Same as last inspection.12/16/2013 Same as last inspection.6/17/2014 Same as last inspection. FIELD_STRUCT_DESC: 3 of 3: 18-inch pipe through levee, 4.4 feet below crown. Cobble revetted sump on waterward side. Siphon breaker in 16-inch metal pipe risers on waterward shoulder. Pump house at toe of landward slope. (Permit No. 9390 - Profpe) Originally included in O+M manual (1959). FS Date: 05/05/2015

Pipe at exit from pumphouse.

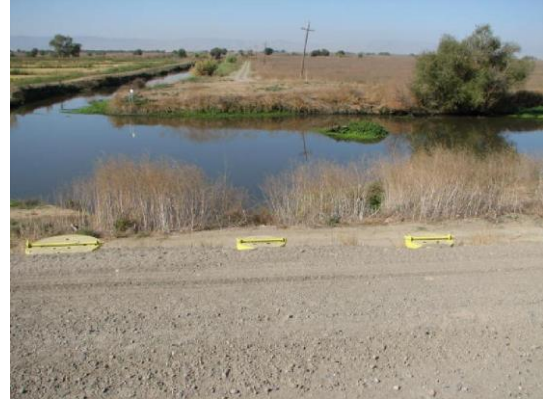
Photo 2 of 3 : UCIP\_FA\_2015\_6446.jpg

LM Start	5.98	Rating **	M	Issue No.	217 (cont)
LM End	5.98	Issue Type +	En	Location *	LS
Category	Supplemental			GPS Latitude/Longitude	
				Start	End
Item	DWR UCIP Field Study			39.114977 °	39.114977 °
				-122.017947 °	-122.017947 °
DWR ID					
Action/Comments					
Inspector Comments: FS_ID:44977 DS_ID:17199 EP_NO: 9390 FS_HLM: 6.119 Repair Type: Non-Urgent Crossing Status: Found UCIP Comments: 5/4/2015 Corssing appears to be in good condition. No noticeable issues to report.Minor oil leak on pump.7/16/2013 Same as last inspection.12/16/2013 Same as last inspection.6/17/2014 Same as last inspection. FIELD_STRUCT_DESC: 3 of 3: 18-inch pipe through levee, 4.4 feet below crown. Cobble revetted sump on waterward side. Siphon breaker in 16-inch metal pipe risers on waterward shoulder. Pump house at toe of landward slope. (Permit No. 9390 - Profpe) Originally included in O+M manual (1959). FS Date: 05/05/2015

Siphon breaker on WS shoulder.

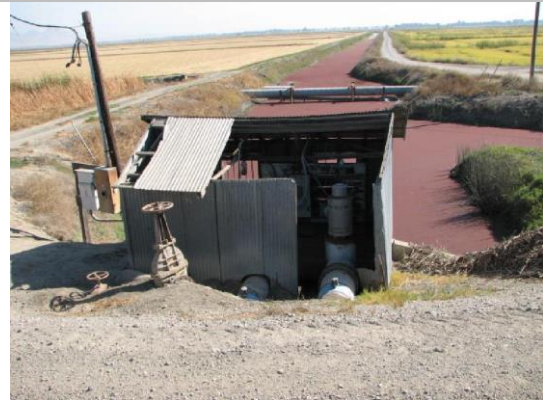
Photo 3 of 3 : UCIP\_FA\_2015\_6447.jpg

Pump house on LS slope.

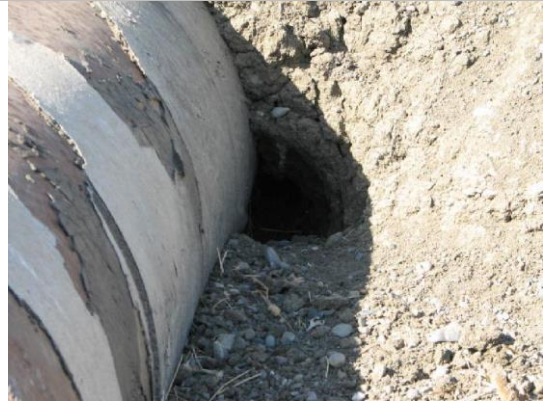
Photo 1 of 3 : UCIP\_FA\_2015\_6448.jpg

LM Start	7.58	Rating **	M	Issue No.	218
LM End	7.58	Issue Type +	En	Location *	CR
Category	Supplemental			GPS Latitude/Longitude	
				Start	End
Item	DWR UCIP Field Study			39.137187 °	39.137187 °
				-122.022793 °	-122.022793 °
DWR ID					
Action/Comments					
Inspector Comments: FS_ID:44978					
DS_ID:17163					
EP_NO: 9390					
FS_HLM: 7.753					
Repair Type: Non-Urgent					
Crossing Status: Found

Animal burrows along side of pipe LS.

Inspector Comments: FS\_ID:44978  
 DS\_ID:17163  
 EP\_NO: 9390  
 FS\_HLM: 7.753  
 Repair Type: Non-Urgent  
 Crossing Status: Found  
 UCIP Comments: 5/4/2015 Corssing appears to be in good condition.  
 No noticeable issues to report.Rodent burrowing along sides of pipe  
 on LS.7/16/2013 Same as last inspection.12/16/2013 Same as last  
 inspection.6/17/2014 Same as last inspection.  
 FIELD\_STRUCT\_DESC: 24-inch steel pipe through levee, 3.0 feet  
 below crown. Both ends capped, terminating on levee slopes. (Permit  
 No. 9390 - Profpe) Originally included in O+M manual (1959).  
 FS Date: 05/05/2015

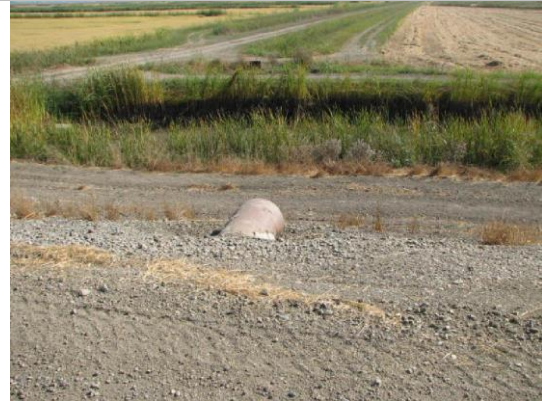
Photo 2 of 3 : UCIP\_FA\_2015\_6449.jpg

Pipe on LS.

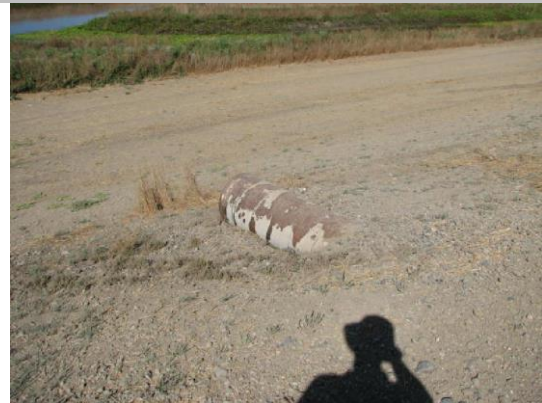
Photo 3 of 3 : UCIP\_FA\_2015\_6450.jpg

Pipe on WS.

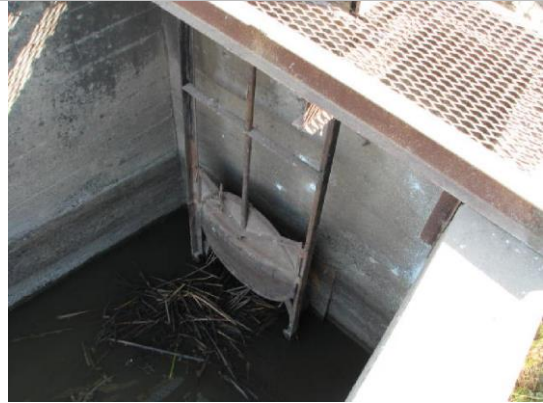
Photo 1 of 2 : UCIP\_FA\_2015\_6451.jpg

LM Start	9.03	Rating **	U	Issue No.	219
LM End	9.03	Issue Type +	En	Location *	CR
Category	Supplemental			GPS Latitude/Longitude	
				Start	End
Item	DWR UCIP Field Study			39.158097 °	39.158097 °
				-122.021706 °	-122.021706 °
DWR ID					
Action/Comments					
Inspector Comments: FS_ID:44980					
DS_ID:17166					
EP_NO: 9390					
FS_HLM: 9.231					
Repair Type: Urgent					
Crossing Status: Found

Slidegate on WS toe.

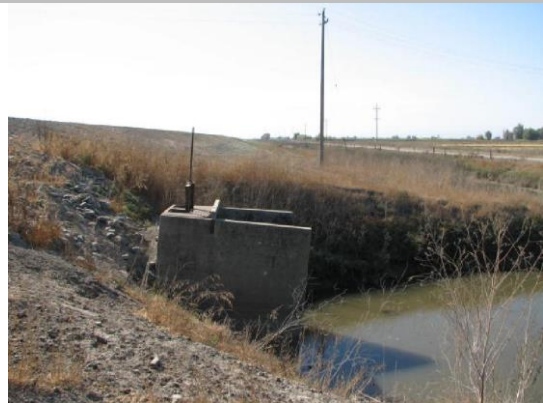
Photo 2 of 2 : UCIP\_FA\_2015\_6452.jpg

Tilting headwall on WS toe.

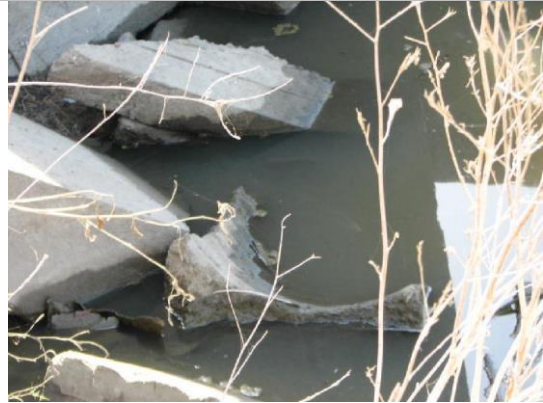
Photo 1 of 3 : UCIP\_FA\_2015\_6453.jpg

LM Start	9.03	Rating **	M	Issue No.	220
LM End	9.03	Issue Type +	En	Location *	CR
Category	Supplemental			GPS Latitude/Longitude	
				Start	End
Item	DWR UCIP Field Study			39.158124 °	39.158124 °
				-122.021701 °	-122.021701 °
DWR ID					
Action/Comments					
Inspector Comments: FS_ID:44981					
DS_ID:17165					
EP_NO: 9390					
FS_HLM: 9.232					
Repair Type: Non-Urgent					
Crossing Status: Indicator Found

headwall debris on LS toe showing evidence of 18-inch cmp.

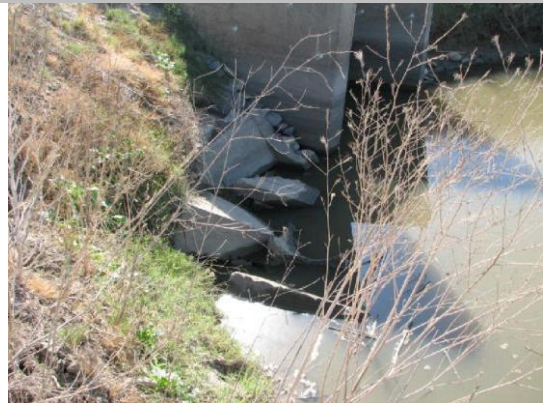
Photo 2 of 3 : UCIP\_FA\_2015\_6454.jpg

headwall debris on LS toe showing evidence of 18-inch cmp.

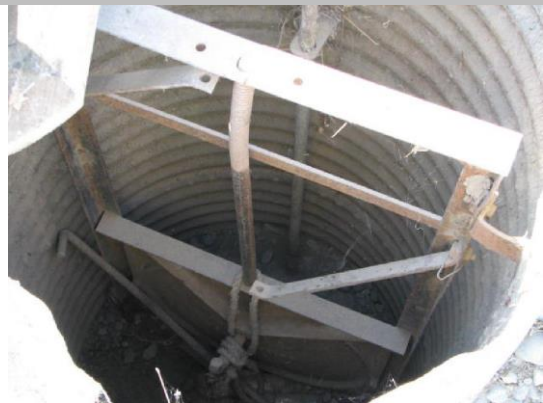
Photo 1 of 2 : UCIP\_FA\_2015\_6456.jpg

Bent and broken actuator on slide gate in 36-inch CMP. Pipe appears to be filled with soil.

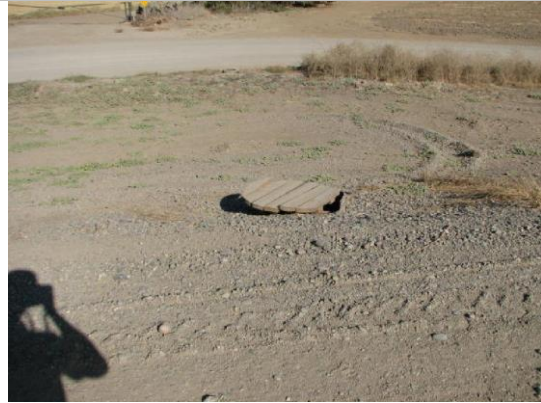
Photo 2 of 2 : UCIP\_FA\_2015\_6457.jpg

cover on 36-inch CMP standpipe on WS slope.
